80 MW Turbine-Generator **Journal-Thrust Bearing Upgrade**

TCE/Turbo Components & Engineering

POWERGEN/The Power Generation Company of
Trinidad & Tobago

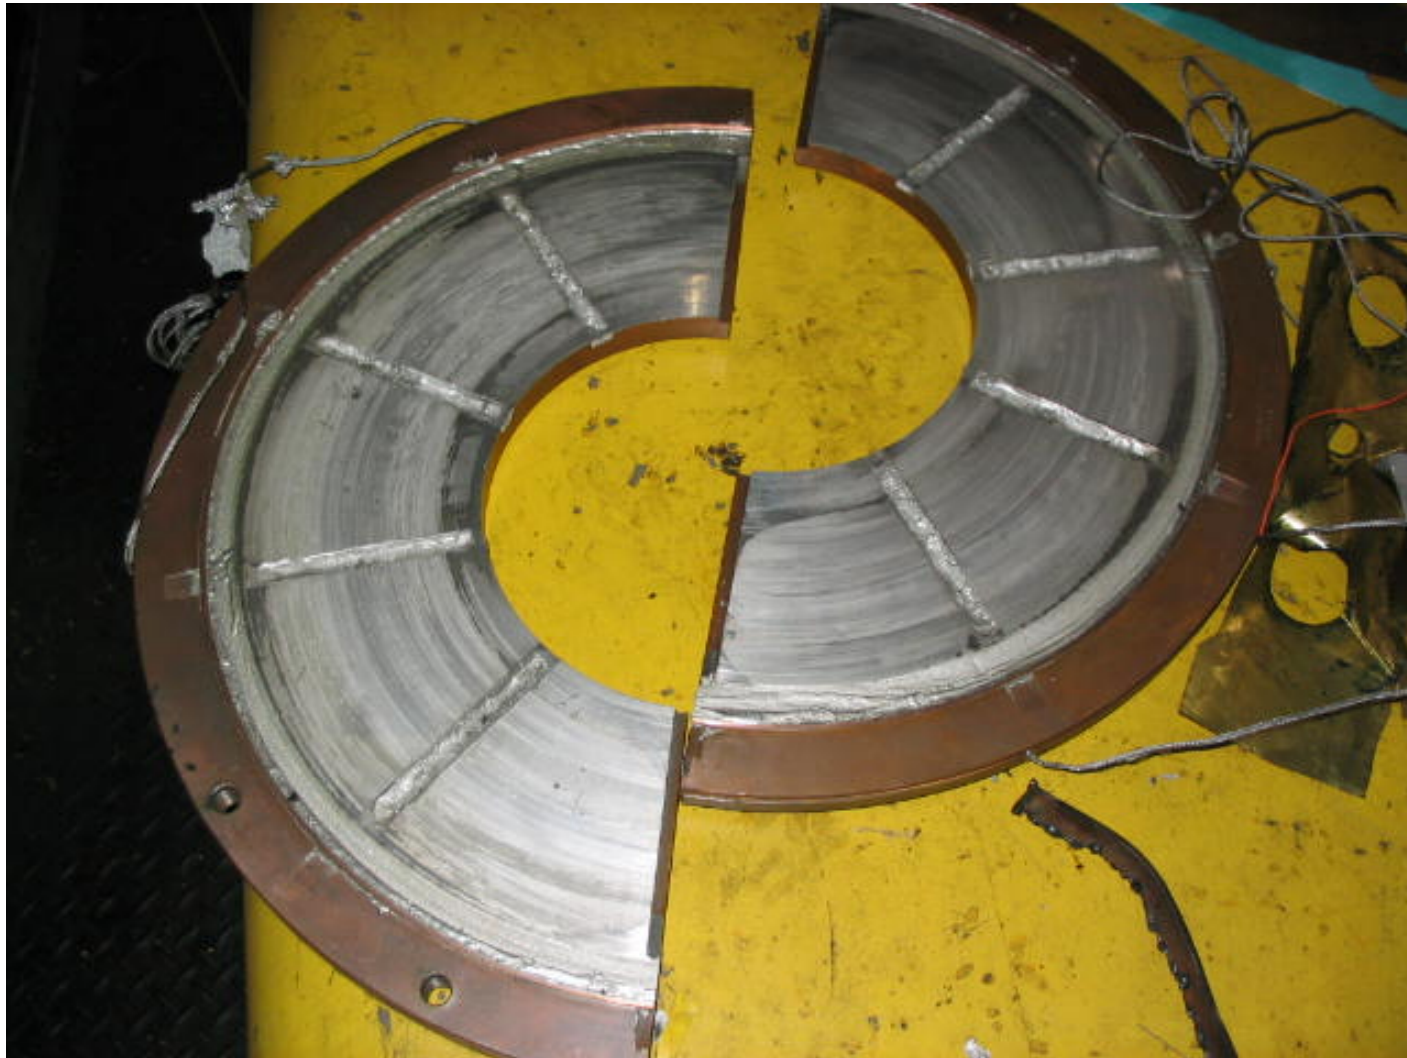
The original bearings had no resistance to the stress and conditions in this machine. The loads, the misalignment, the large percentage of water in the oil are factors producing numerous failures of the thrust and journal bearings, which required maintenance shut-downs. These factors did not allow the machine to operate at full capacity.

Failed active thrust bearing

A combination journal/thrust assembly was designed and installed in the turbine. This assembly incorporated a fully equalized ball & socket tilting pad thrust bearing with directed lubrication on the active side, the continued use of a taper land plate on the inactive side, and a ball & socket tilting pad journal bearing.

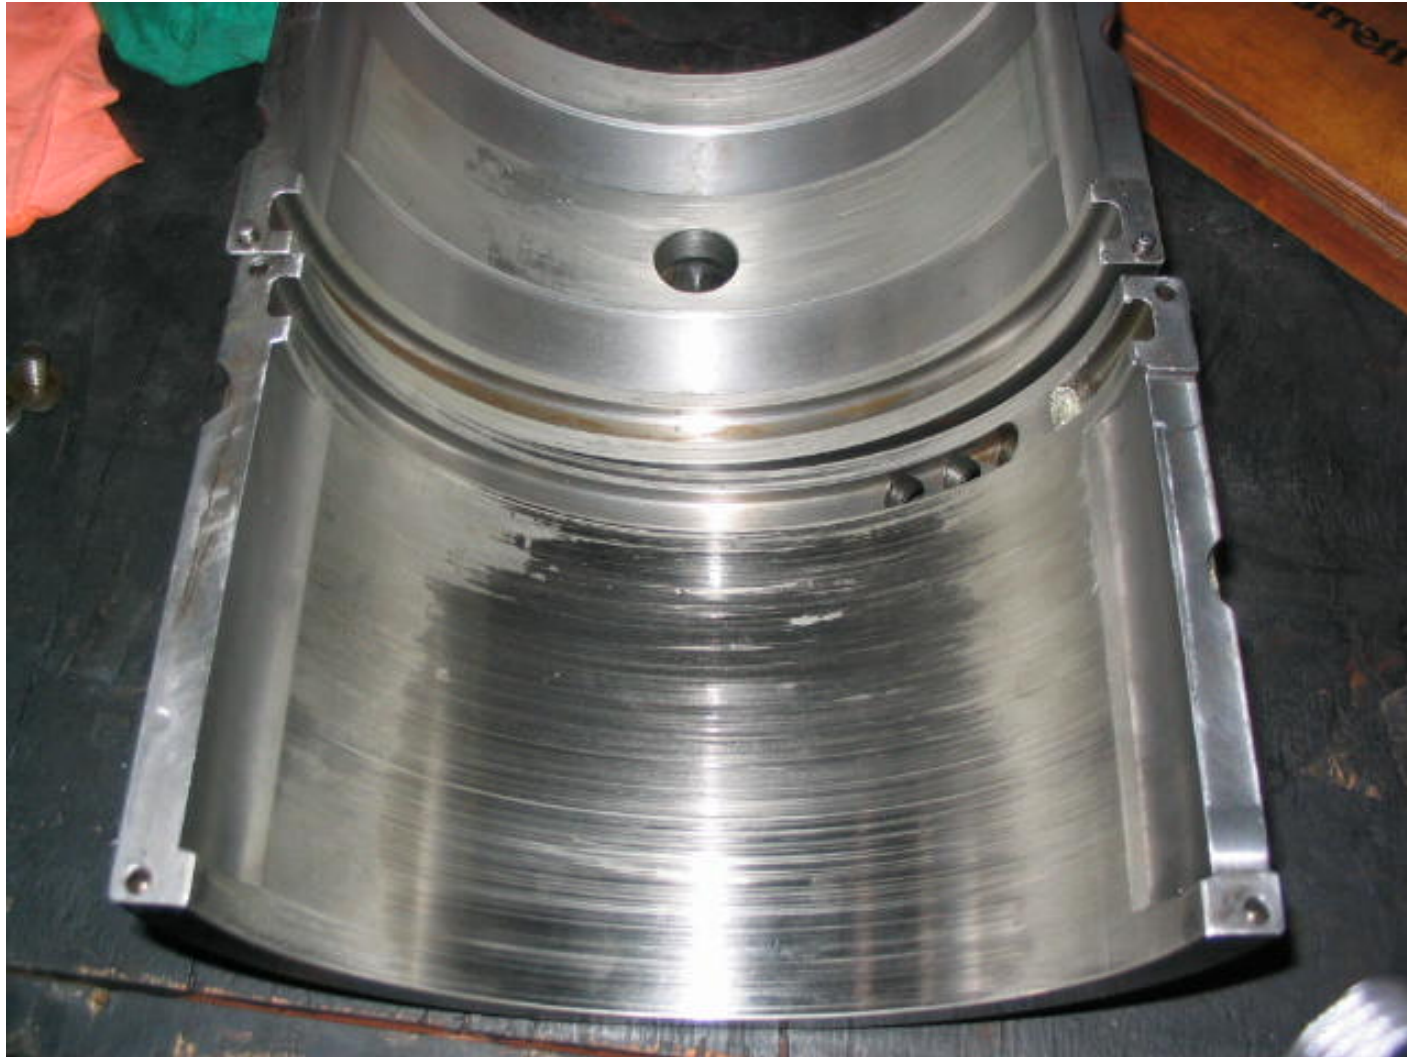
Wiping of Journal Bearing

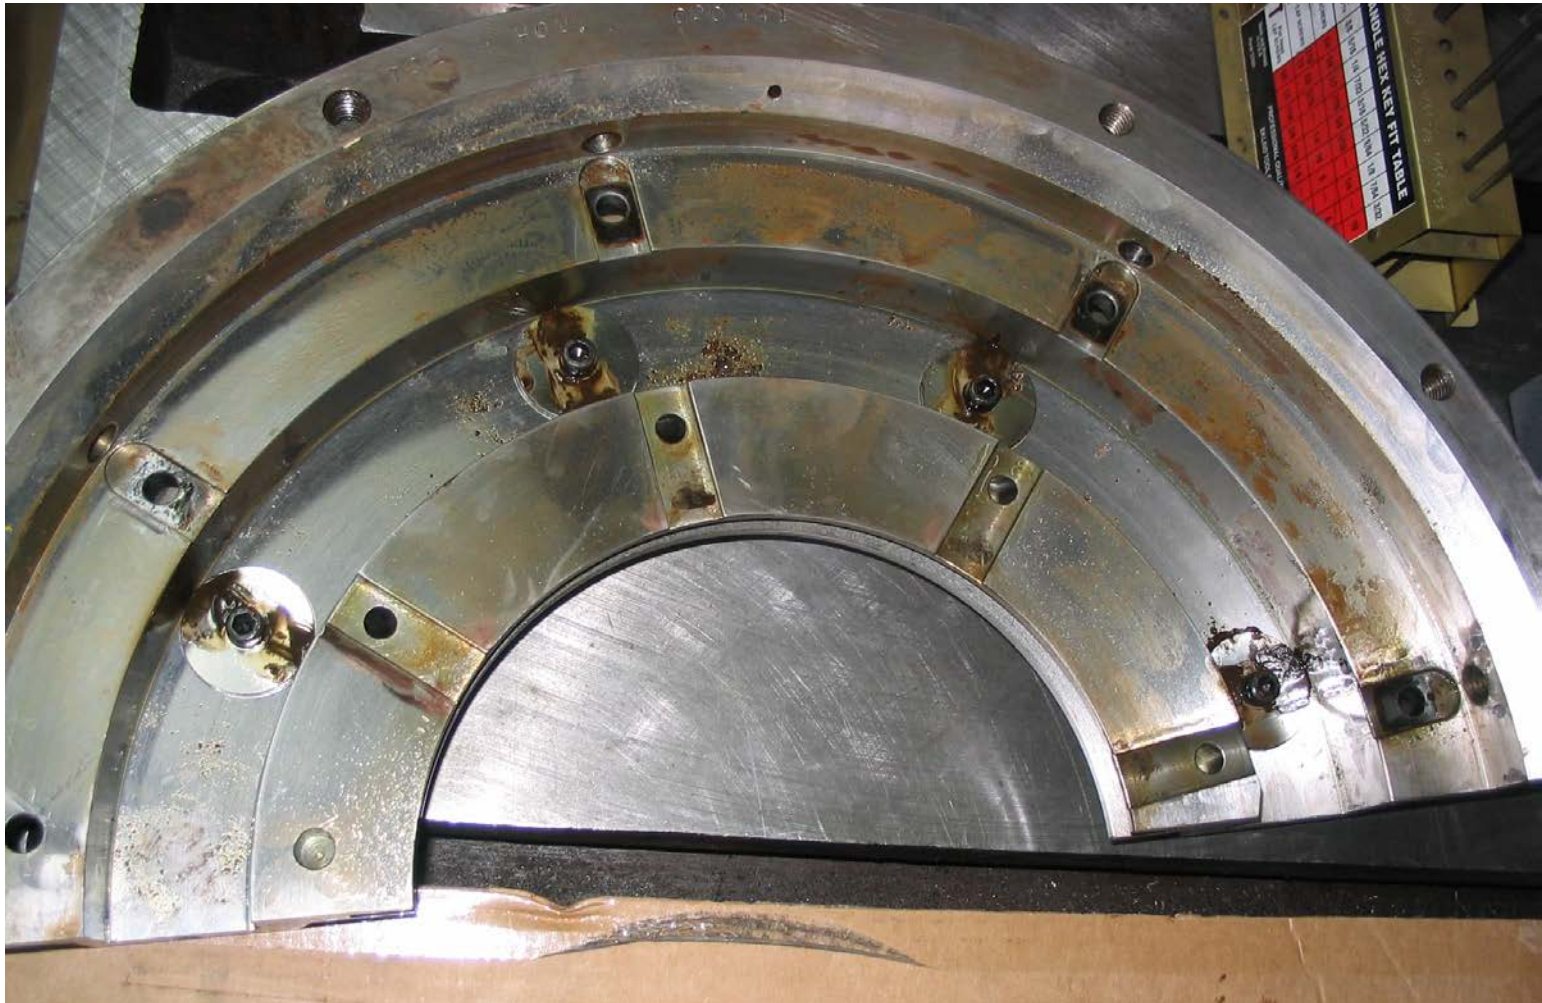
After one year in service, the customer had concerns about the percentage of water in the oil.

The bearing steel thrust bearing surfaces attacked by rust.

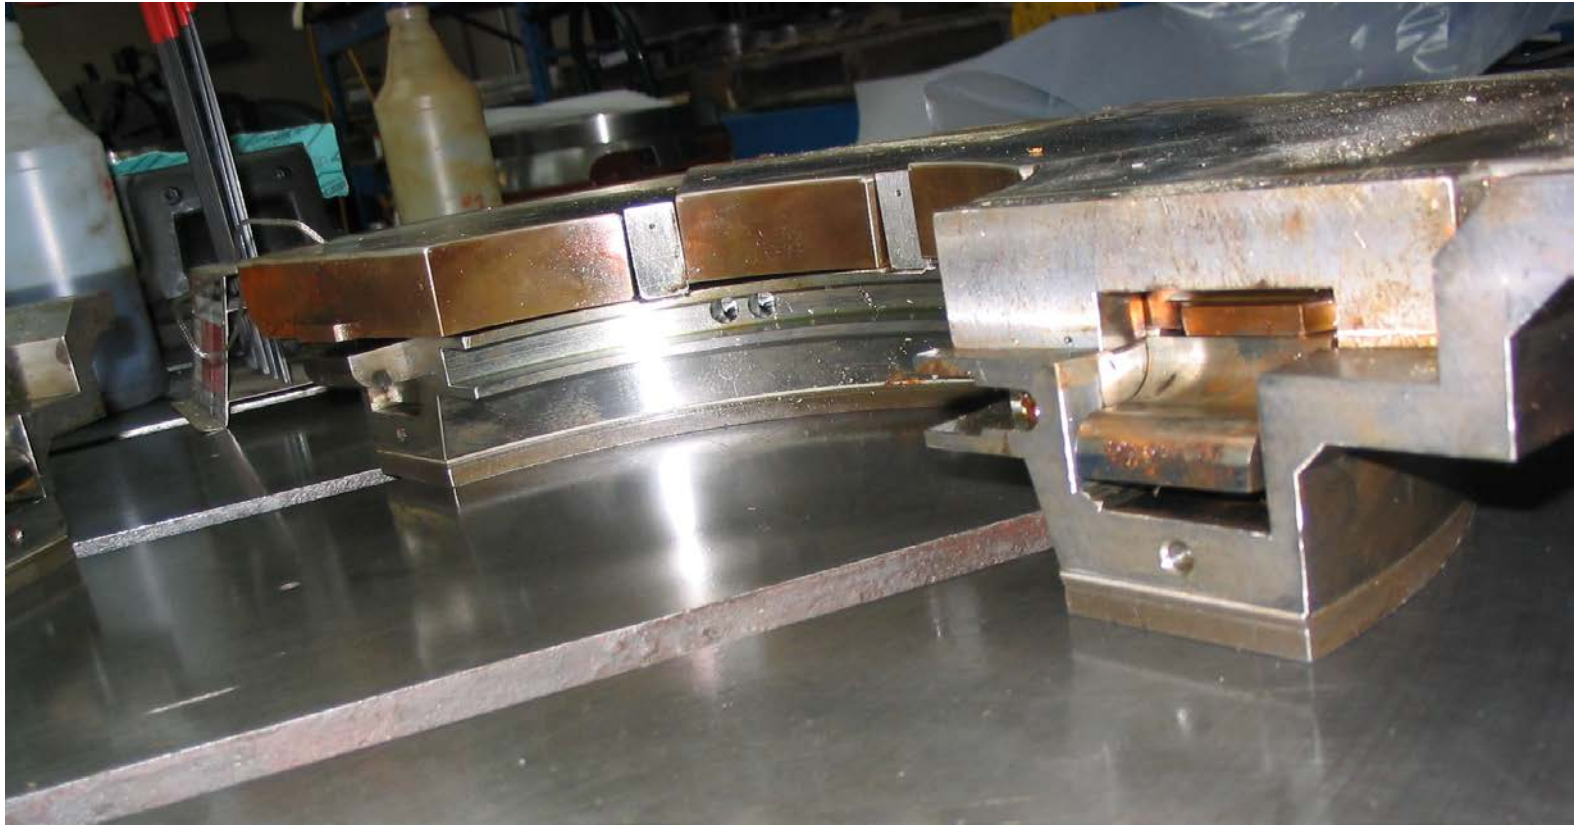
The thrust bearing has rusted surfaces in all steel parts.
